VMI Hybrid Restoration Guide

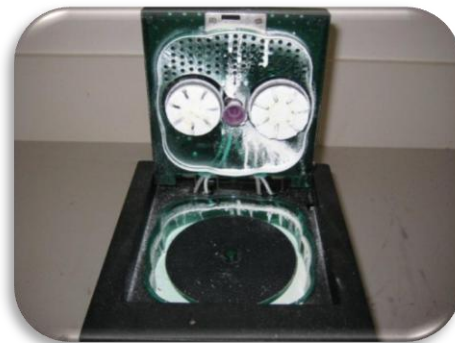
- If the spill tray is not cleaned regularly
- If the **Buffing Pads** are not replaced when replacements are due
- If the **Top Cover** is left closed with both the **Buffing Pads** and **Platen** installed.

If any of the above instances describe your VMI Hybrid unit, then it will require some effort to get it back in good working order.
